737 GRAPHITE COMPOSITE FLIGHT SPOILER FLIGHT SERVICE EVALUATION

FIFTH ANNUAL REPORT

MAY 1978 THROUGH APRIL 1979

Prepared under contract NAS1-11668 by
BOEING COMMERCIAL AIRPLANE COMPANY
P.O. Box 3707
Seattle, Washington 98124

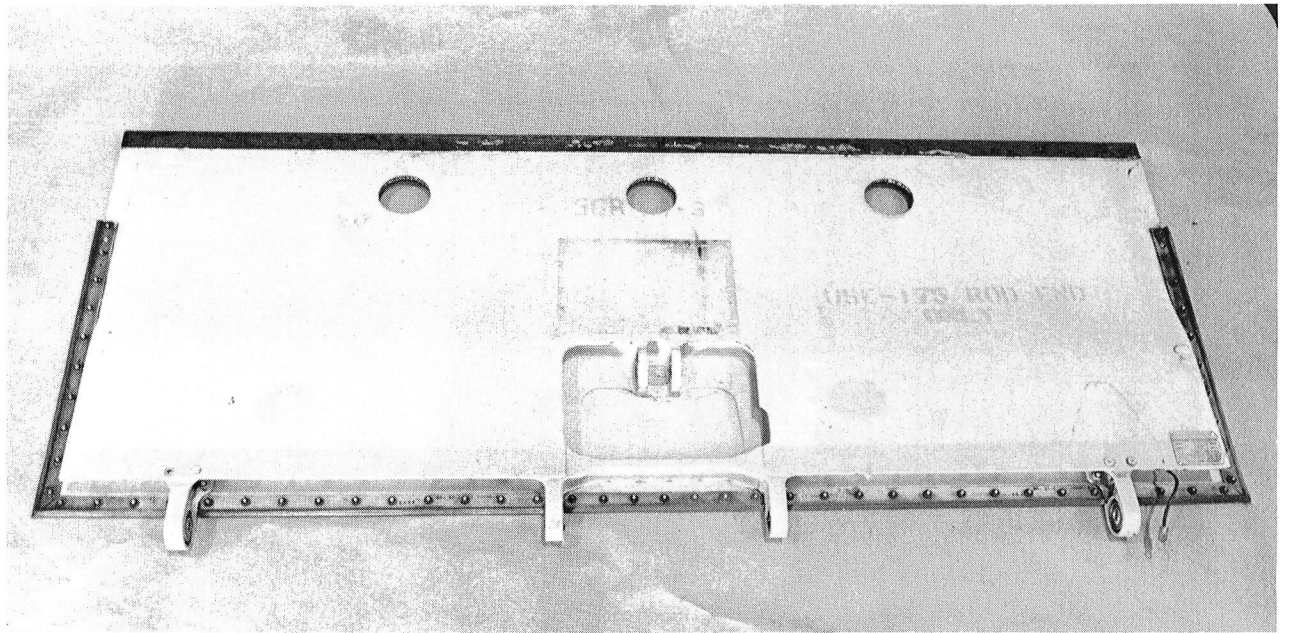
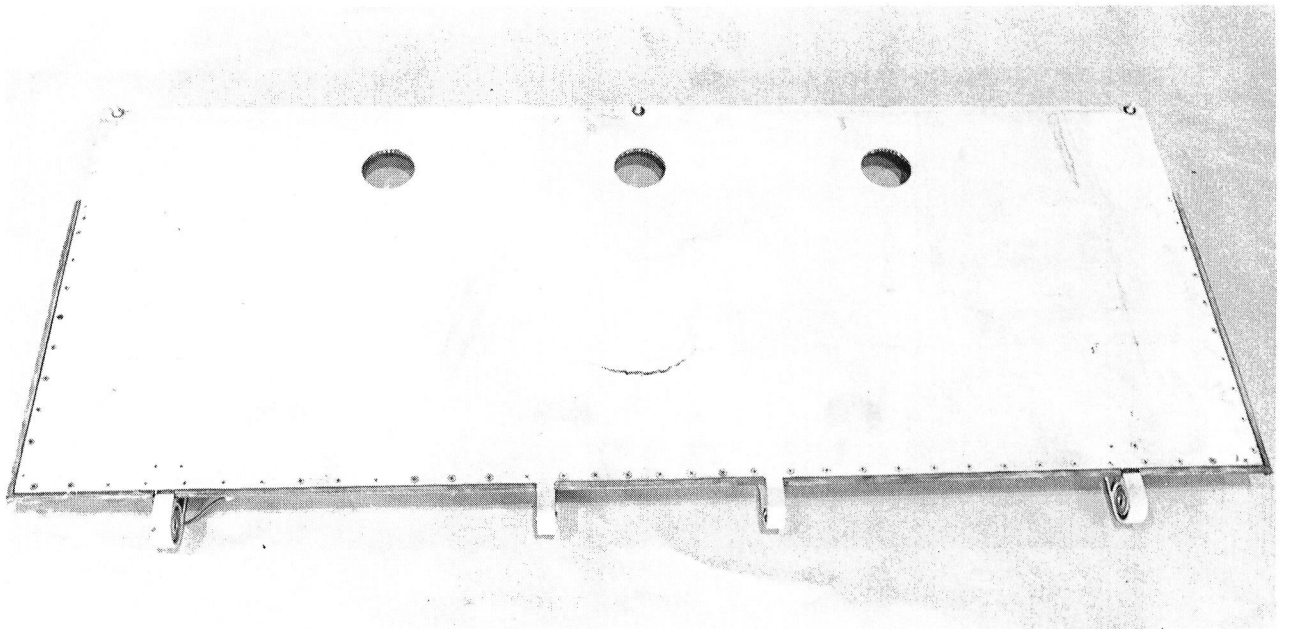
Figure 2.—Spoiler S/N 0020 Static Test

During this reporting period, six spoilers were removed from the flight service program for evaluation and test. All removed spoilers were reinspected using the ultrasonic through-transmission C-scan, and the results were compared to the records made at the time of original fabrication. No detectable differences were noted in this comparison on four of the six units. The remaining two units had minor discrepancies deemed to warrant repair prior to return to service. The sixth fourth-year spoiler, S/N 0111 (previously unreported) was also processed through the ultrasonic inspection, cleared, and returned to revenue service. Three of the fifth-year spoilers (S/N 0020, 0067, and 0096) were then selected to be destructively tested to measure residual static strength following the specified calendar period of exposure. Table 4 shows the data from all of the scheduled fifth-year removals and summarizes the strength and stiffness data from the three units that were static tested. Figures 2, 3, and 4 show the spoiler panels after static testing. Figures 5, 6, and 7 are plots of the load-deflection data for these three panels.

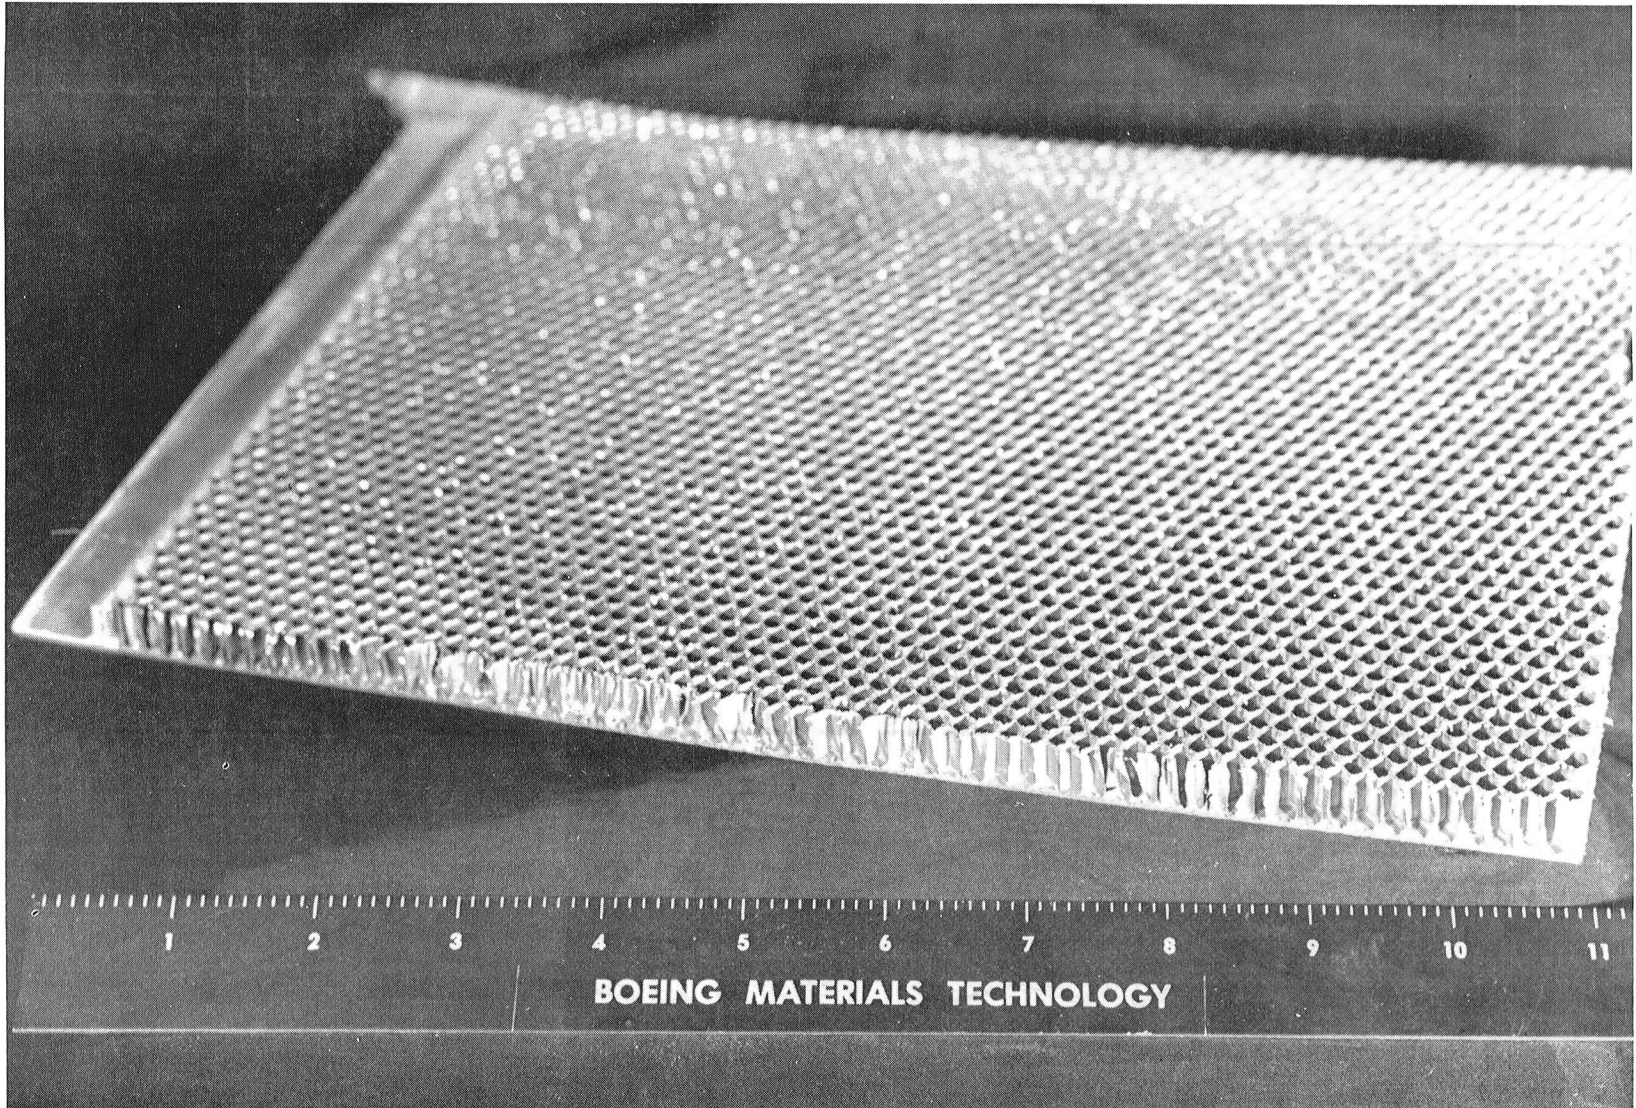
Figure 9.—Post-Test Corrosion Teardown Inspection (S/N 0096)

Following static test, all three test units were sectioned to investigate for core corrosion. The procedure used was similar to that employed on S/N 0054 as described in reference 4. All three panels were completely free of any evidence of corrosion in the honeycomb core. Figure 9 shows a typical section taken from S/N 0096.

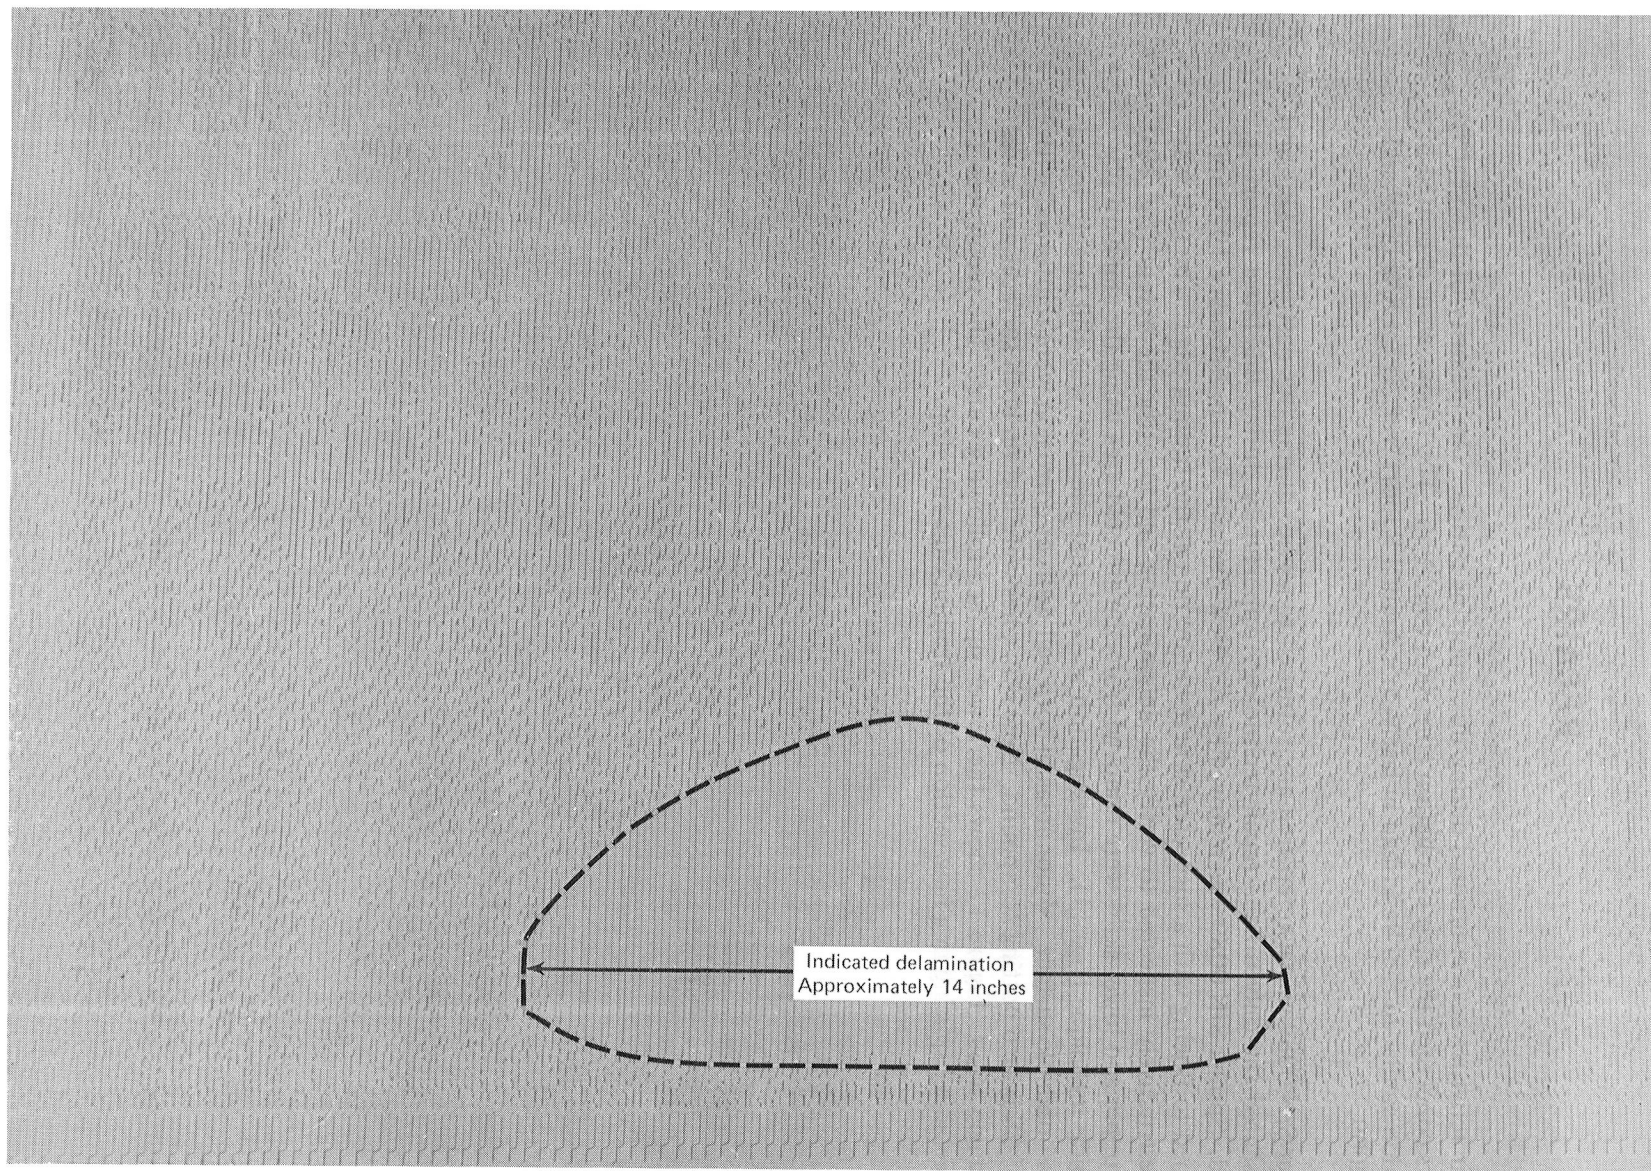
Figure 10.—Nondestructive Inspection of Skin Delamination (S/N 0089)

Spoiler S/N 0089 was also repaired and returned to service during this past year. This unit represented the only unique repair technology opportunity during this latest reporting period. Spoiler S/N 0089 was removed by Air New Zealand, Ltd. in February 1978 and returned to Boeing with a suspected skin delamination at the trailing edge. The unit was nondestructively inspected to verify the delamination and identify the extent (fig. 10). Both upper and lower skins were removed from the affected area using the standard ply stripping technique (fig. 11). Investigation showed that the core was still largely intact with a bondable surface. Minor areas of torn cell walls or corrosion were reinforced with BMS 5-28 type 6 potting compound. New skin plies were laid on both surfaces and cured in a single stage. Figure 12 shows the lower surface following cure. The repair was completed by splicing in a new section of the trailing edge rub strip.
